## Appendix C: Southern F126

### Field Notes and Pictures

Utility: ComEd      Investigators: J. Stutsman & J. Spencer

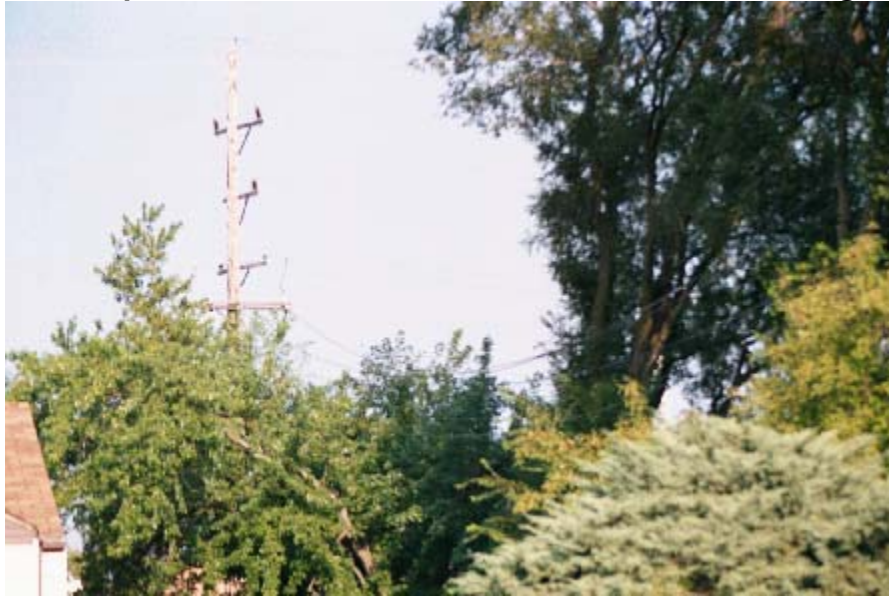
### Picture C1

Slack span into trees at Wentworth and 231<sup>st</sup> St. in Steger
